CALSPAN ADVANCED TECHNOLOGY CENTER

IMPROVED LIGHTWEIGHT SUBCOMPACT
SIDE STRUCTURE CRASH TEST REPORT

Calspan Report No. 6225-V-16

TEST: TEST NO. 14
TYPE OF TEST: CAR-TO-CAR FRONT-TO-SIDE OBLIQUE
TEST DATE: 22 AUGUST 1979

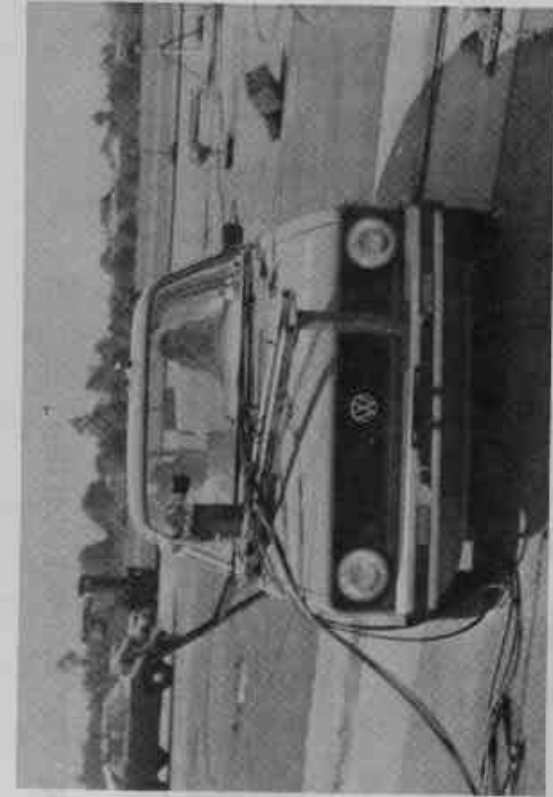
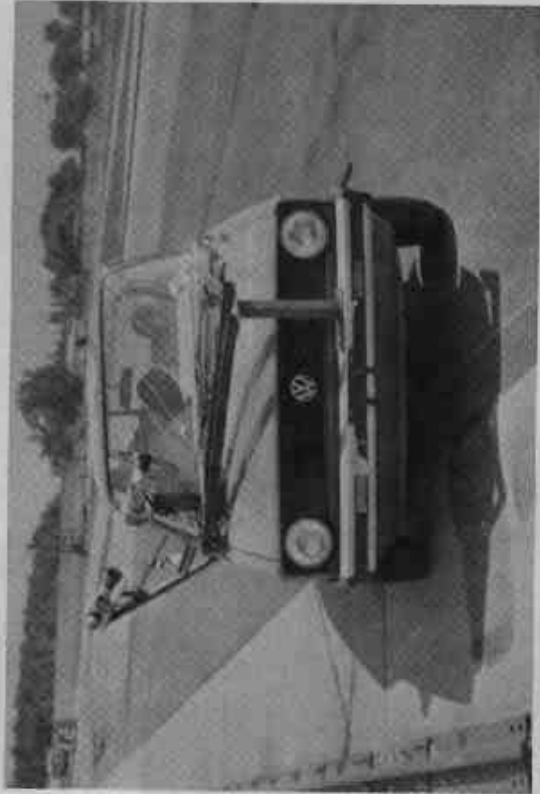
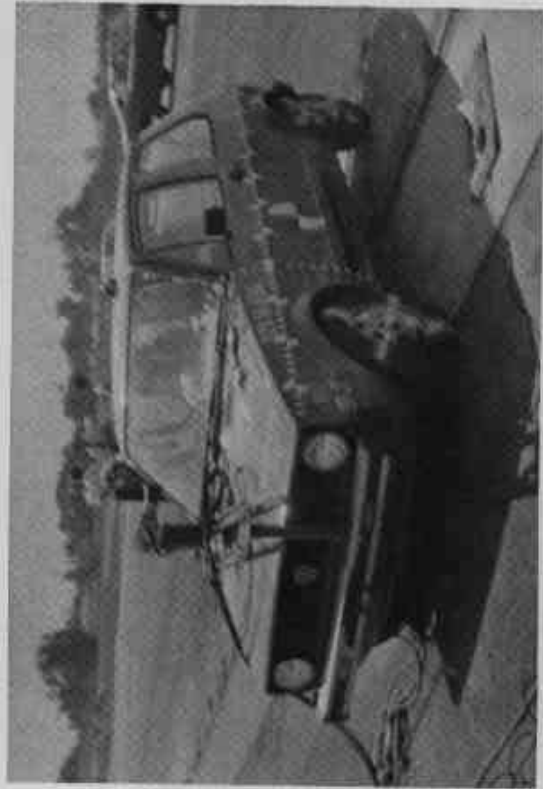
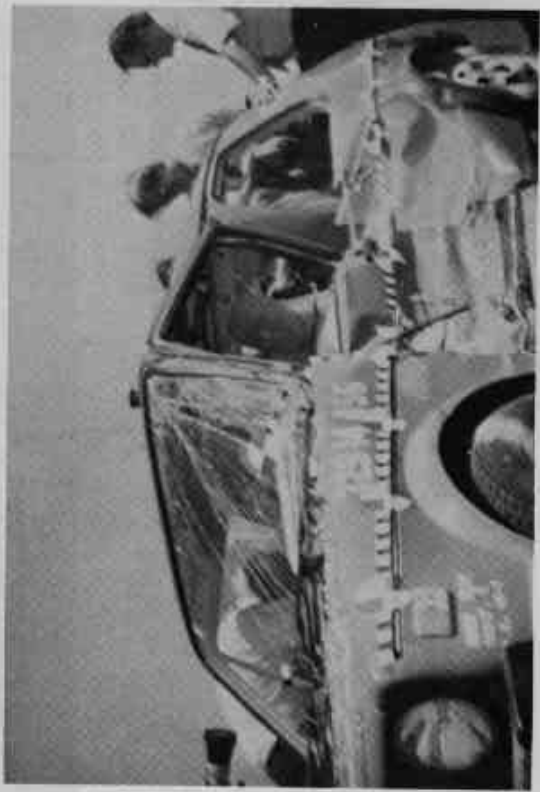
Figure 3 PRE- AND POST-TEST NO. 14 - VEHICLE 2, 1976 VW RABBIT

GLAZING Windshield cracked but in place, Driver side front and rear windows broken out

SEAT ANCHORAGES Driver seat crushed, Passenger seat sustained little damage

GENERAL COMMENTS Door hinges and interlocks held but A-pillar, B-pillar, roof, and sill yielded. A-pillar rotated counterclockwise (looking down on vehicle). B-pillar failed in bending at mid-height joint. Roof buckled at B-pillar connection. Sill rotated upward due to interlocks. In general the stiffened side structure transferred load into vehicle body which could not sustain it.
